Pentium® II Xeon™ Processor Specification Update

Release Date: January 2000

Order Number: 243776-019

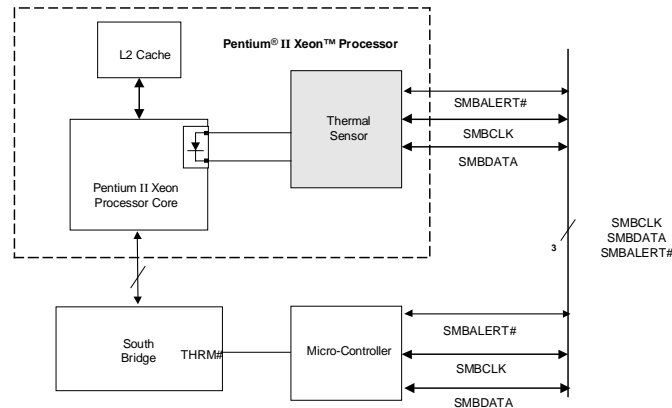
Figure 1. An Example of Microcontroller Driven Thermal Management

D30. Thermal Sensor May Assert SMBALERT# Incorrectly

Problem: The Pentium II Xeon processor has a thermal sensor that monitors the processor core's temperature. The thermal sensor asserts SMBALERT# if the processor temperature exceeds the temperature limits set in the Alarm Threshold Registers (T_{HIGH} , T_{LOW}). It also sets the corresponding Status Register bits to identify the cause of the interrupt. Figure 1 gives one example of the how the SMBALERT# signal could be used in a system.

Under the conditions described below, the thermal sensor incorrectly generates the SMBALERT# interrupt. All of the following conditions must be met to trigger a false interrupt:

Workaround: Three different (mutually exclusive) workarounds are possible:
